# Teignbridge District Conservation Area Character Appraisals

*Ipplpen*

## 1:0 INTRODUCTION

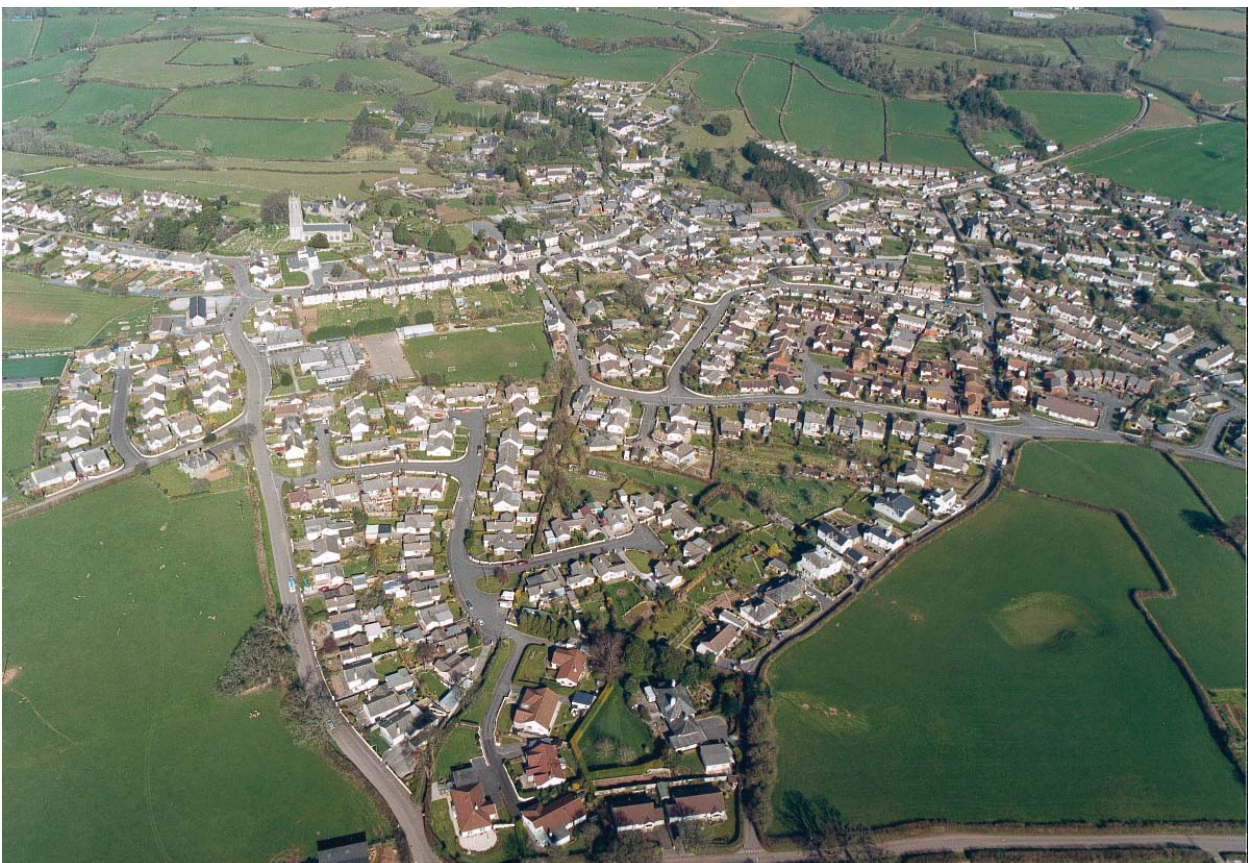
*The simple plan of Ipplepen has been greatly diluted by modern development, especially to the south and east*

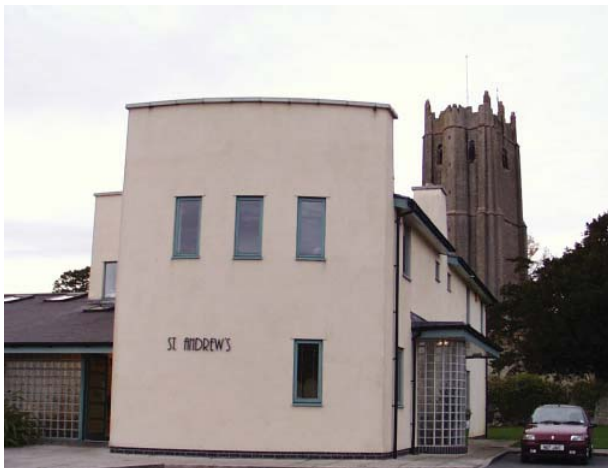
*The medical centre is quite respectful in its scale and materials*

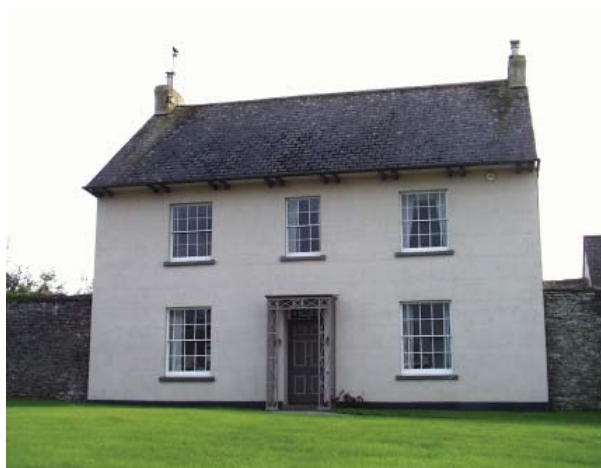
*Rosemount - a typical later Georgian residence*

While a few grand houses were built in Fore Street and East Street in the early 19th century. Rosemount, on East Street has a very unusual crescent-shaped carriage drive in front, while Elm Cottage nearby is a very unusual classical stuccoed house, built of cob. These suggest a rise in local wealth at this time, probably agricultural, possibly related to trade.

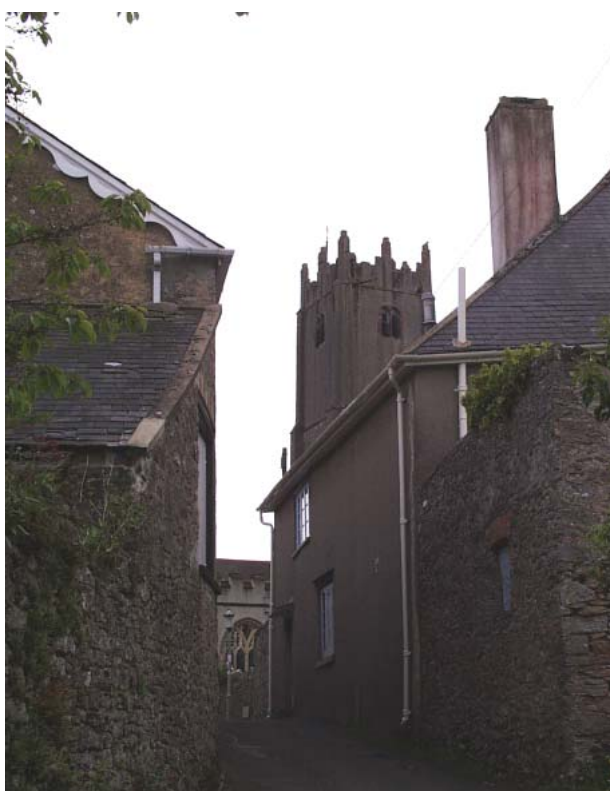
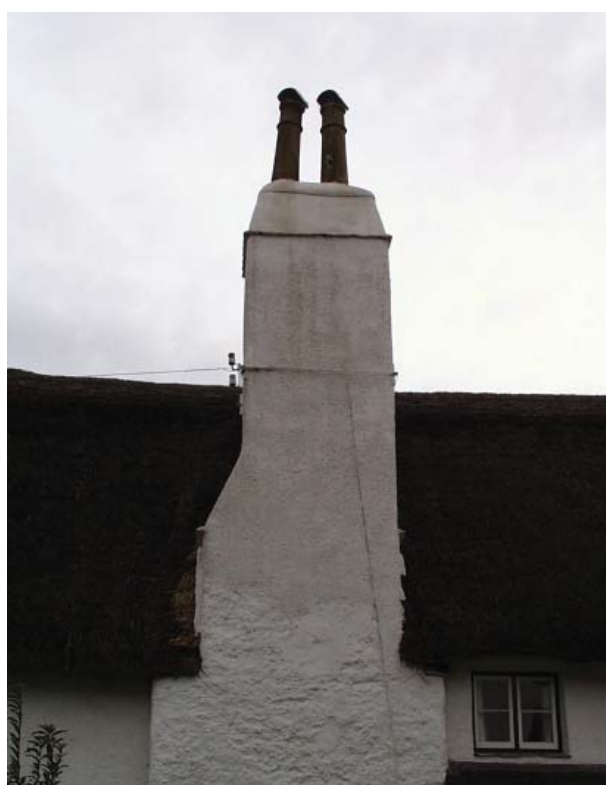
*Limestone is the main building material, but it is often rendered and/or limewashed*

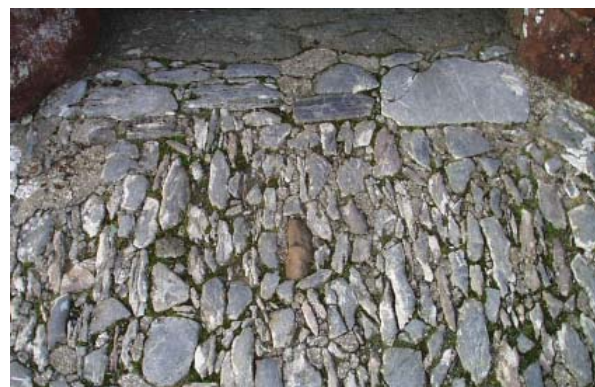
*Historic cobbled pavement*

**7.5 SURFACING:** Some surviving remnants of historic surfacing illustrate the types of treatments used in the past. Traces of angular limestone and chert cobbles survive in strips along Dornafield Road and East Street. It is likely that other parts of the village were treated in the same way in the past.

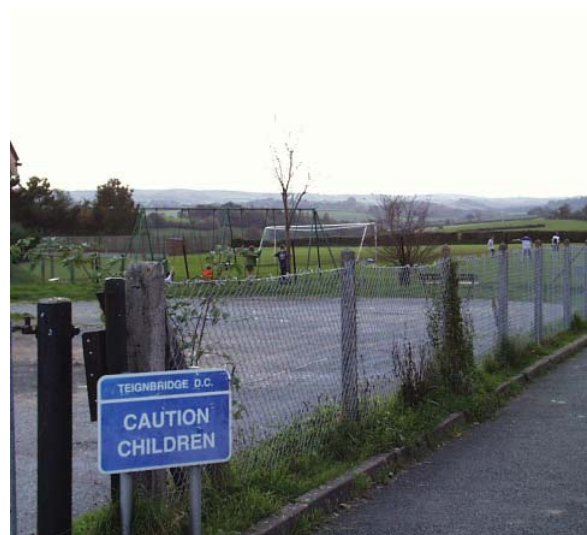
*The choice of fencing can diminish the quality of a space*

**ENCLOSURE:** Brick or block walls, even if rendered are not acceptable. Larch-lap, close-boarded or chain link fencing and evergreen hedges, especially conifers.

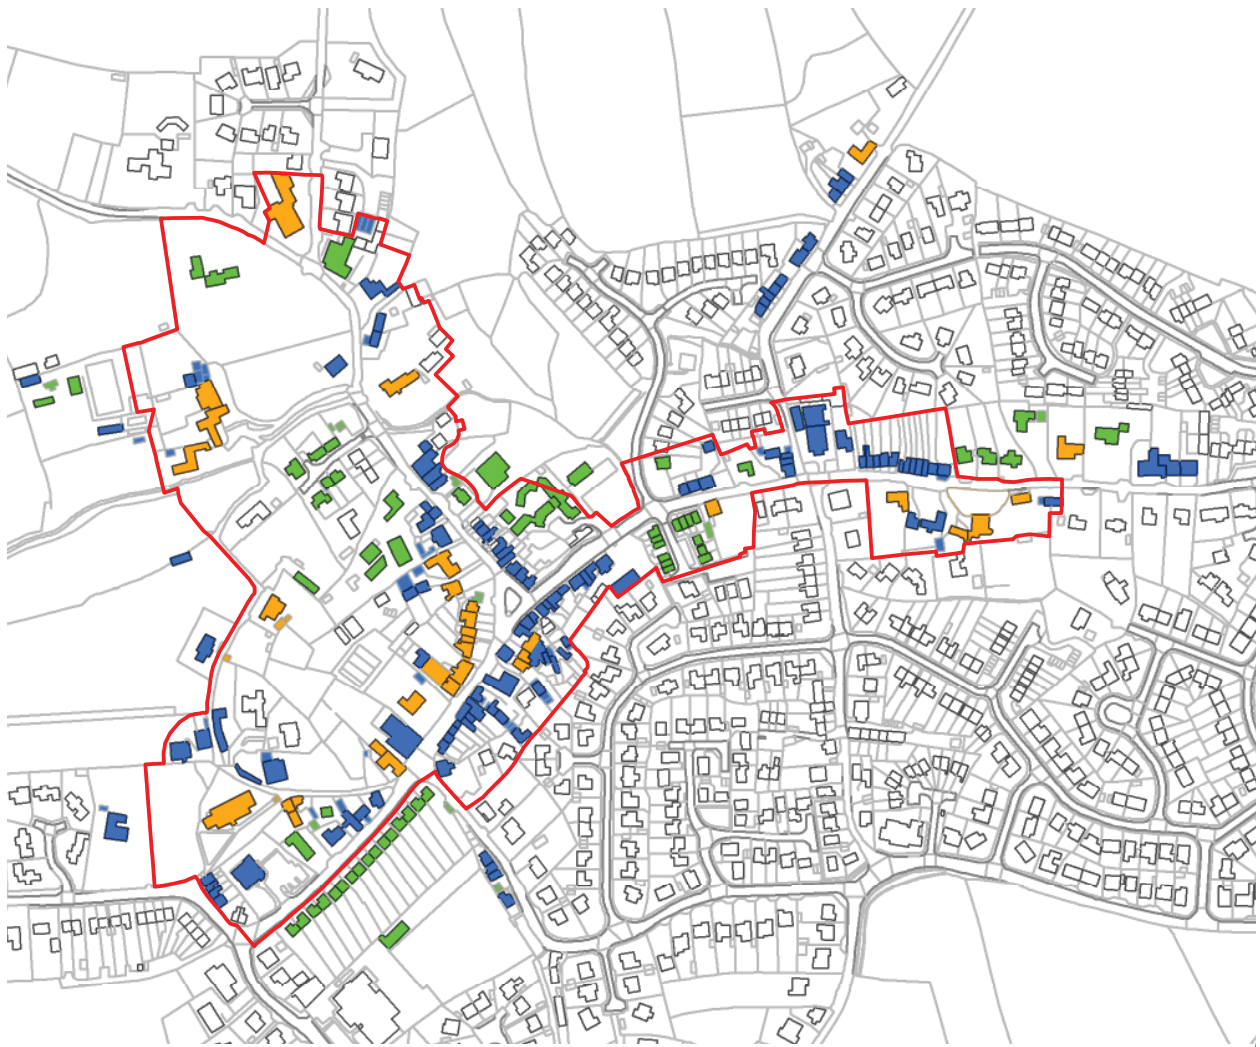
## *Key to Character Survey Map*

- Category 1: Outstanding
- Category 2: Positive
- Category 3: Neutral/Negative

The purpose of this survey is to identify which buildings within the conservation area contribute positively or negatively to townscape character. Three characters bands are used (see map 1) and the criteria for each are summarised below.
